Toyota 120 Series Prado Grande

Replacement of the height-adjustable and electronically-controlled suspension with conventional coil springs and dampers.

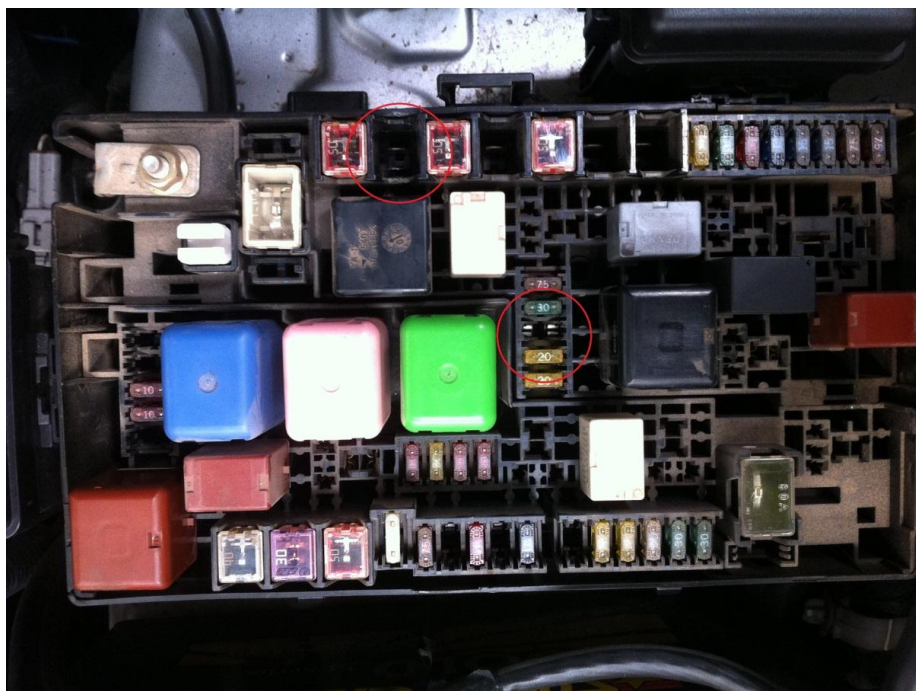
1. Ensure that the vehicle's ignition switch is in the 'off' position and remains in this position during all of the following steps.
2. Access the under-bonnet fuse box and remove the 10A 'AIRSUS No.2' and the 50A 'AIRSUS' fuses. (pictured below) Refit the fuse box cover and close the bonnet.

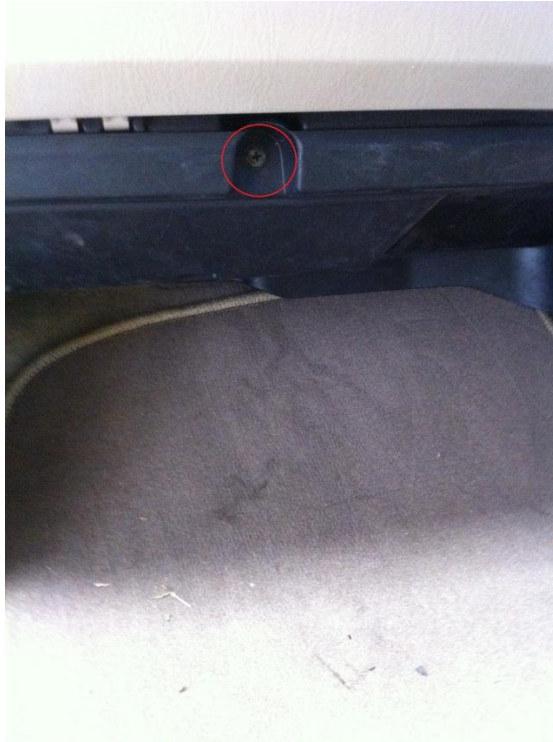
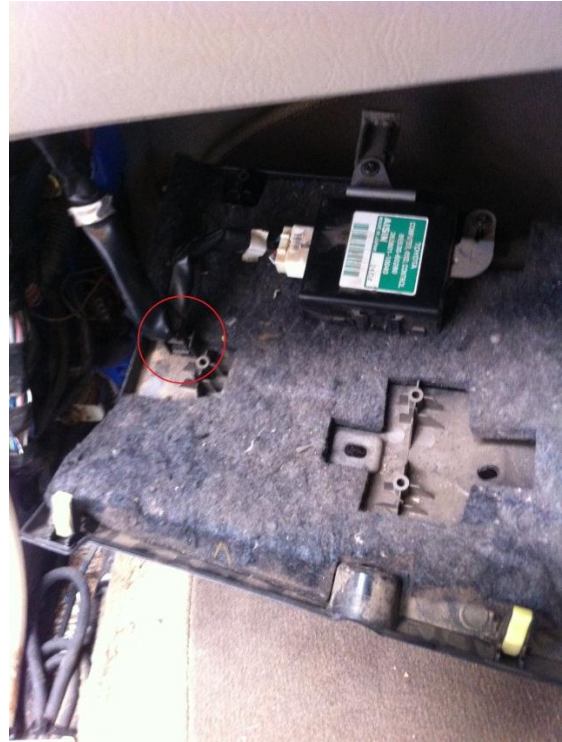
3. Remove the passenger side lower dashboard trim by removing the one Phillips-head screw (pictured below) and then pulling the trim in a rearward direction. Once the trim is removed, disconnect the circled wiring harness clip (pictured below) from the trim to allow ease of access to the kick-panel.

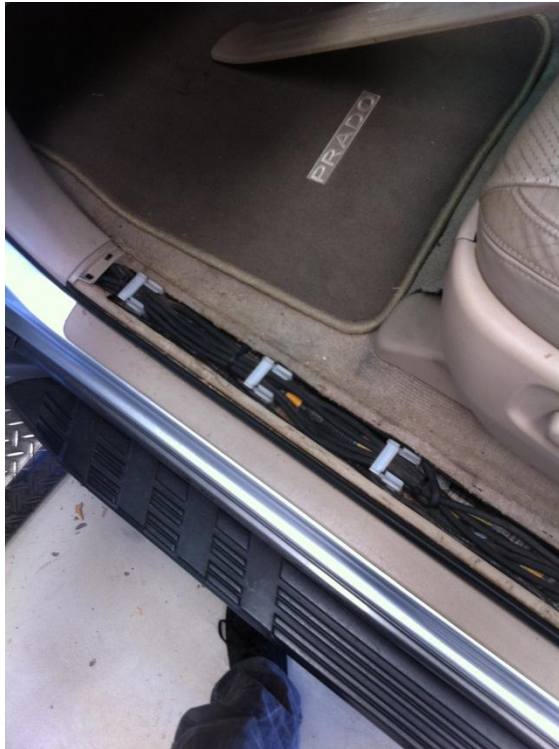
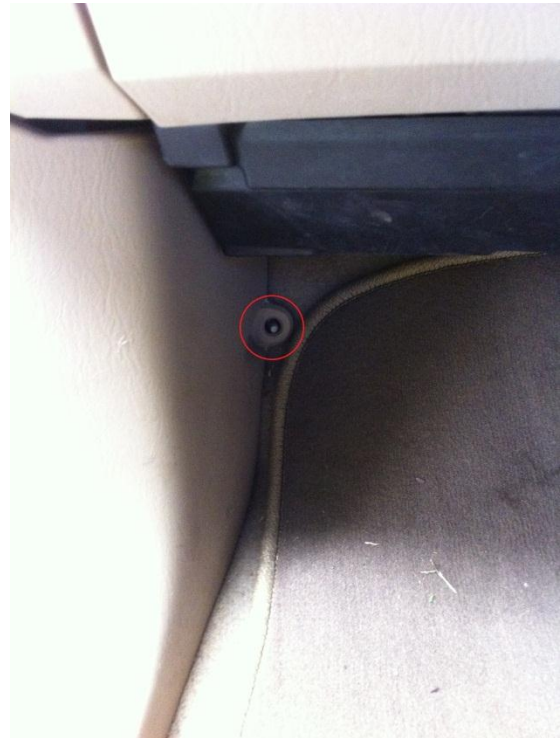
4. Remove the passenger side front door scuff plate and the passenger side kick panel black plastic retaining nut from the locating stud (pictured below). Once the black plastic nut is removed, the kick panel can be removed by pulling it in a rearward direction.

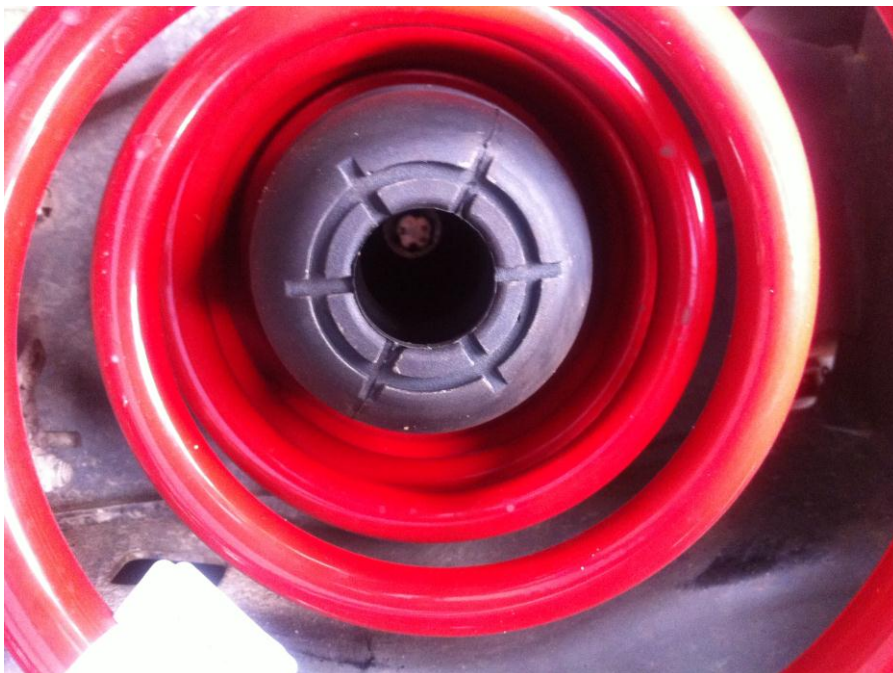
1. Replace the front struts using either OE or upgraded springs as per normal process. Ensure that the now-defunct wiring harnesses and connectors for the old electronic dampers are secured with cable-ties.
2. Remove the rear airbags but leave the existing airlines in situ.
3. Secure the 5899 bump stops into the rear upper spring locating recess using bolts, nuts and large washers. The bolt will go through the existing hole in the centre of the spring locating recess. (see below)

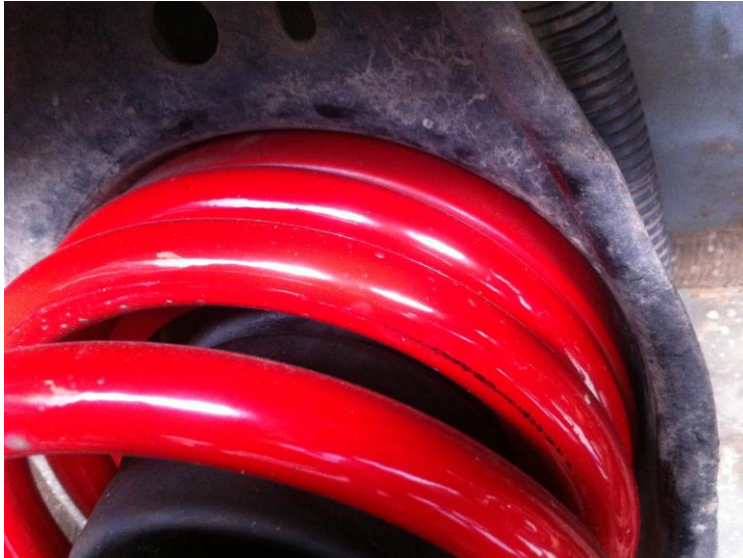
4. After securing the bump stops in place, install the Pedders EP8316/20 spring spacer into the upper spring locating recess around the 5899; ensuring that the raised inner spring guide of the spacer is facing downwards. (see below)

SPRING/SPACERS ARE NOT
USED ON REAR LIFTED COILS 7839

****NOTE**** Due to the use of the Pedders EP8316/20 Spring Spacer as a spring guide, the final rim-to-guard measurement *may* be 15mm more than the advertised amount for the coil spring part number in the Prado 120 Series application.
